# Hot water tank condition assessment

## USING MORDEN SCANNING EQUIPMENT

Páll Baldvin Sveinsson  
Operation Manager District Heating

2019

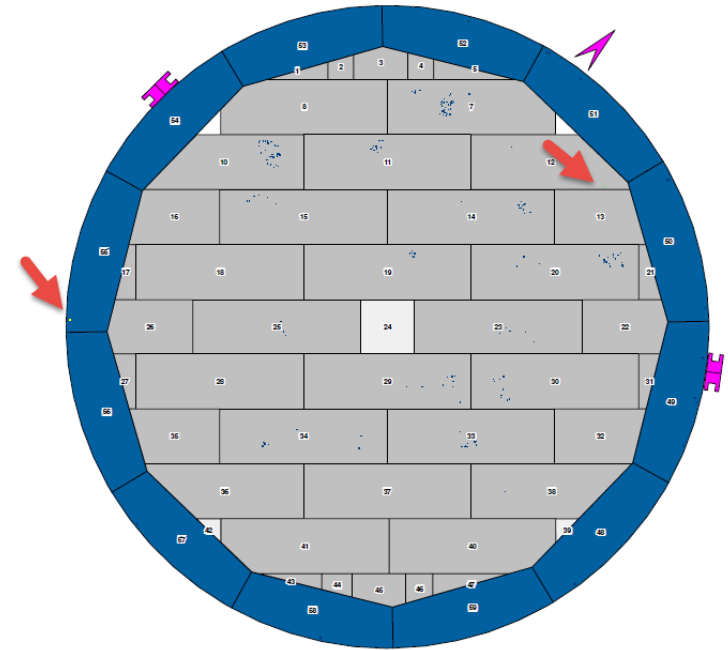
Condition of the tank's bottom

- Damaged in two places where the metal loss is 40% or more

No.	Plate No.	X Pos. [mm]	Y Pos. [mm]	X Size [mm]	Y Size [mm]	Depth [%]	Type	Method	Location	Classification
1	12	1850	4777	8	11	40	Metal Loss	TBit	SK	Inspection Side
2	55	1387	5083	16	20	65	Metal Loss	TBit	AN / CA	Inspection Side

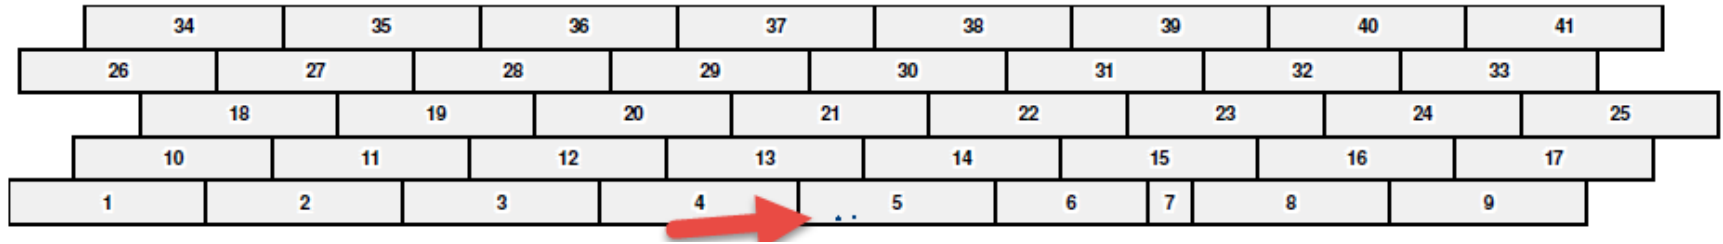
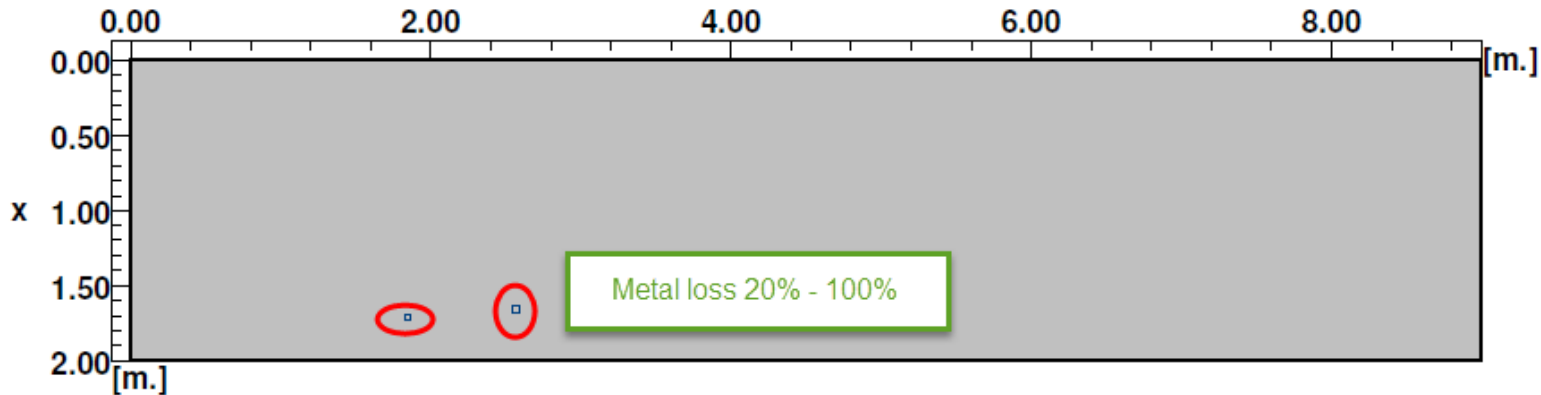
Condition of the tank's walls

- Corrosion found in two places, metal loss more than 20%

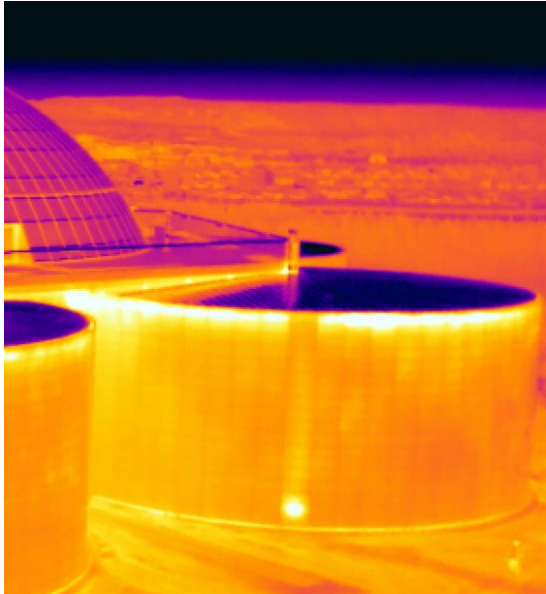
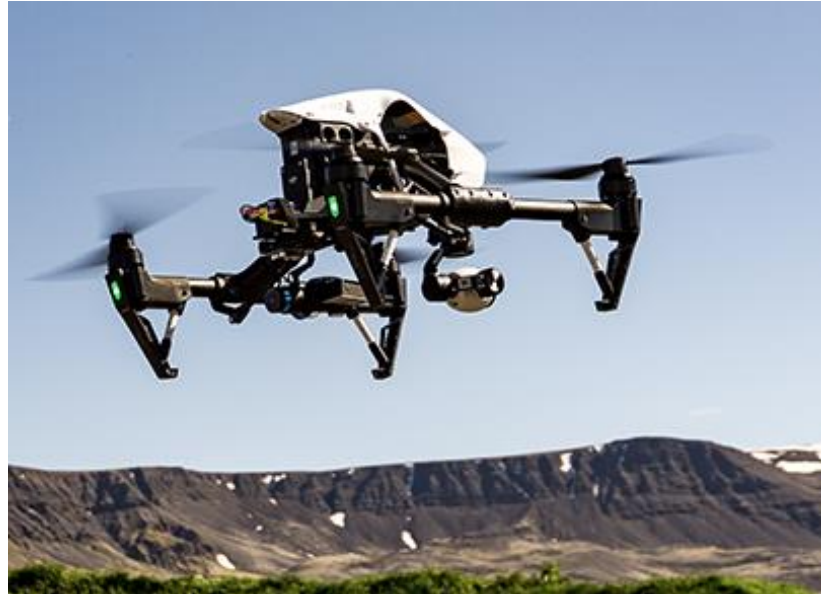
Use of drones for thermal imaging

- Tanks found in good condition
