# Hot water tank condition assessment

## USING MORDEN SCANNING EQUIPMENT

Páll Baldvin Sveinsson  
Operation Manager District Heating

2019

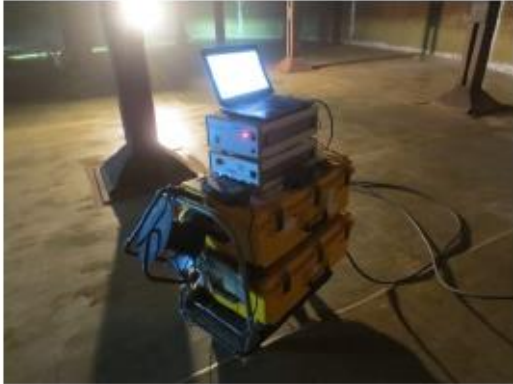
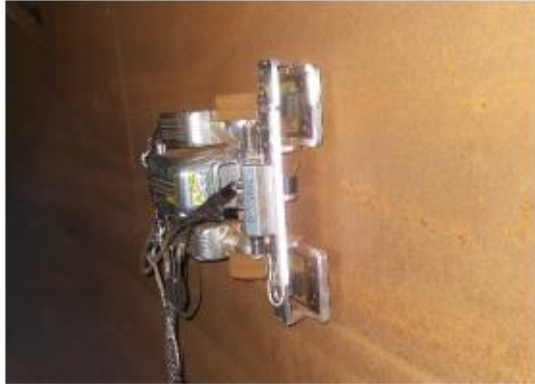
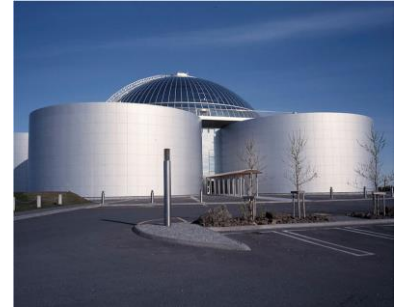
Full scale survey of one district heating tank performed in 2017

- Experts in tank scanning were contracted
- Bottom and walls scanned
- Roof is visually inspected

Construction year: 1987  
Capacity: 8.500 m<sup>3</sup>

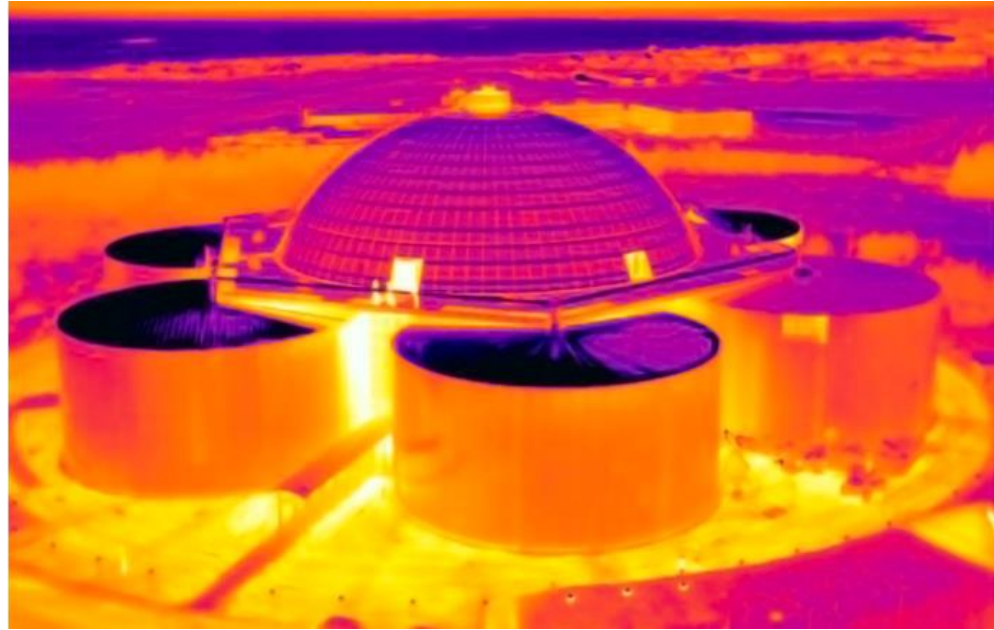
- Can be viewed from outside with tank in operation
- Good analysis of poor insulation
- Benefits
  - Quick analysis
  - No need for tank entry
  - No need to open the weathercoat
